To:	Kezar Lake Watershed Association	From:	Jake Riley Topsham ME Office
File:	Stantec PN 195600843	Date:	April 10, 2020

Reference: Summary of Cold Brook Habitat Reconnaissance Survey

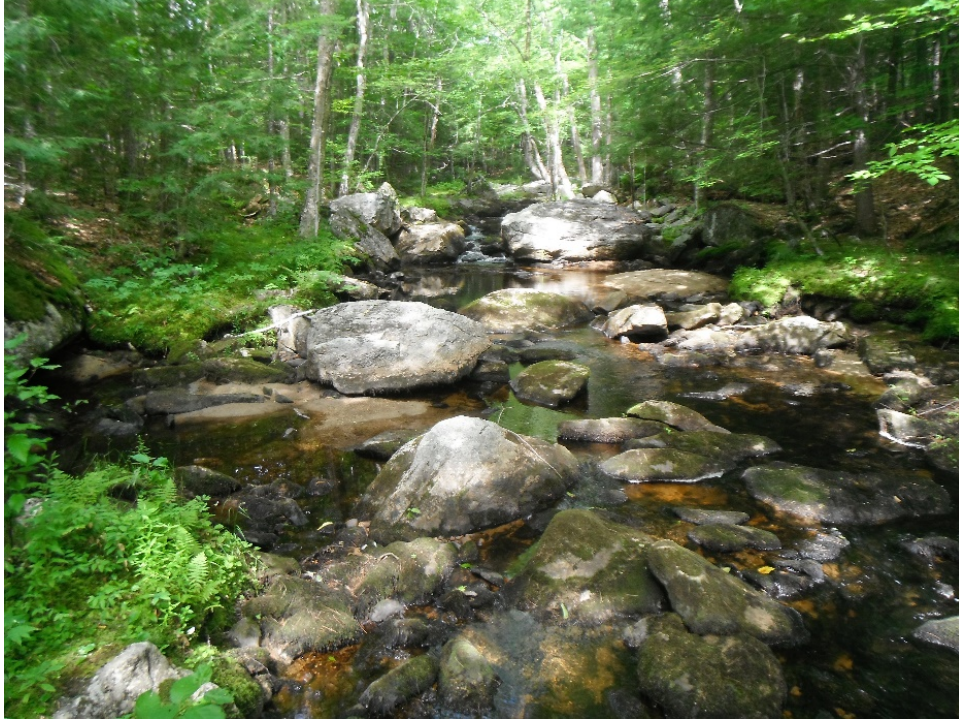
Segment 1 was approximately 0.5 RM and extended from the Slide Brook bridge upstream to the right angle turn in Cold Brook to the west (Figure 1). This lower section of Cold Brook had good canopy cover and riparian vegetation consisting of mixed hardwood forest (Photo 1). The higher quality stream habitat in this lower segment included plunge pools with a stable boulder and bedrock dominated substrate with fine sediment settled out in the deeper pools (Photo 1). One brook trout young-of-year was observed in this steeper high-quality habitat, however, there was minimal evidence of appropriately sized gravel for brook trout spawning. Upstream of this lower section was a beaver-influenced long flatter reach dominated by deep pool and runs including a large pond feature that was too deep and dark to observe any fish (Photo 2). The pond habitat was at the confluence of the tributary draining Little Pond from the north (Figure 1). Above this reach, there was a long stretch of Cold Brook in an open meadow that was dominated by beaver activity with active lodges and multiple blown out beaver dams (Photo 3). The beaver dams held back some spawning substrate (i.e., gravel) but there was a lack of riffles and/or pool tails with well-oxygenated water preferred for spawning. Just before the right angle turn to the west at the upstream limit of Segment 1, there was a steeper reach with more canopy cover, cobble substrate, and two exposed blue PVC pipes in the stream channel, which could have been used for water irrigation for the historic golf course located adjacent and to the east of Cold Brook.

Photo 1. Steep bedrock and boulder section of Cold Brook with fine sediment in the pools.

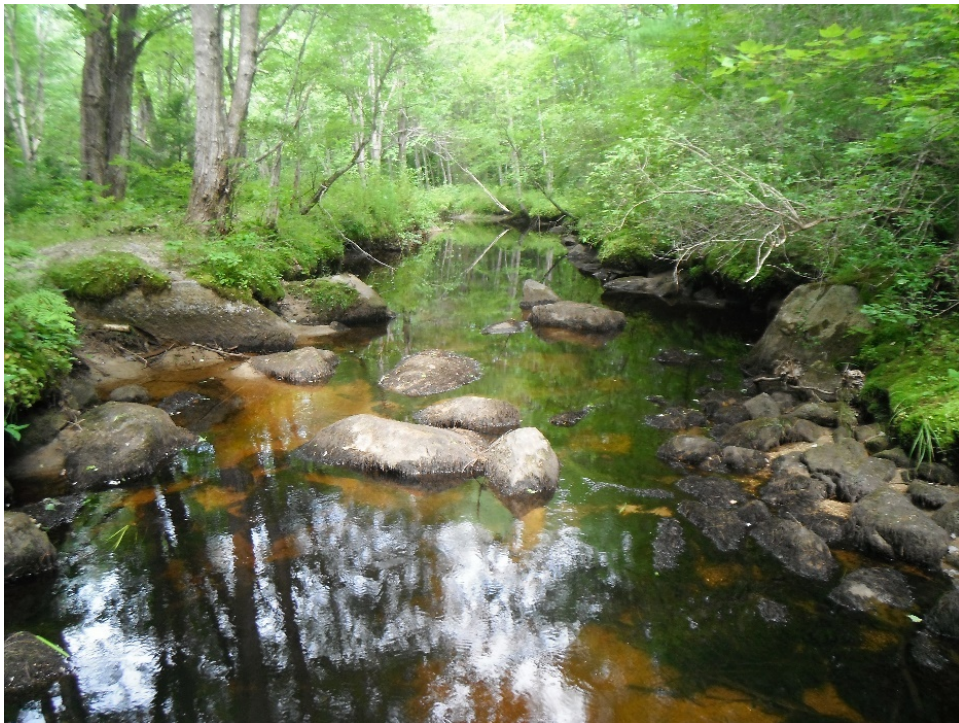
Photo 2. Slower moving section of Cold Brook dominated by deep pools and long runs.

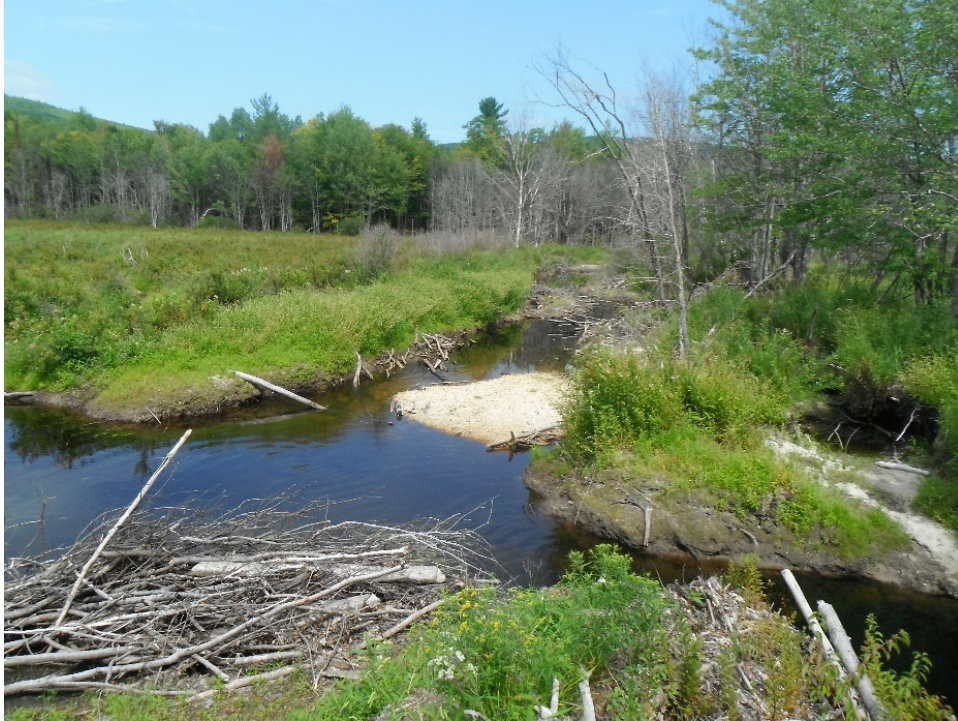
Photo 3. Section of Cold Brook dominated by beaver activity.

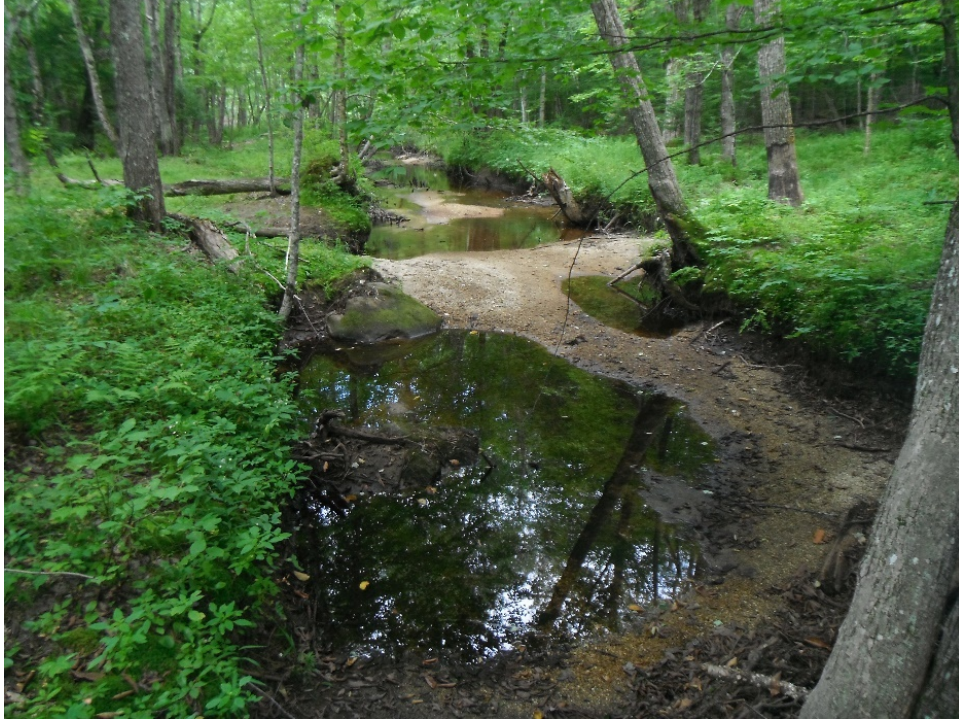
This short segment (approximately 0.15 RM) of Cold Brook was dominated by slow moving pools and runs with sedimentation and large woody debris jams (Figure 1, Photo 4). At the junction of Adams Brook and Cold Brook, there was approximately twice as much flow in Adams Brook than Cold Brook (Photo 5). Both tributaries were dominated by fine sediment in the stream bed. This section of Cold Brook did not have preferred brook trout habitat and no fish were observed in this section.

Photo 4. Slower section of Cold Brook with large woody debris jams holding back sand, gravel, and organic debris.

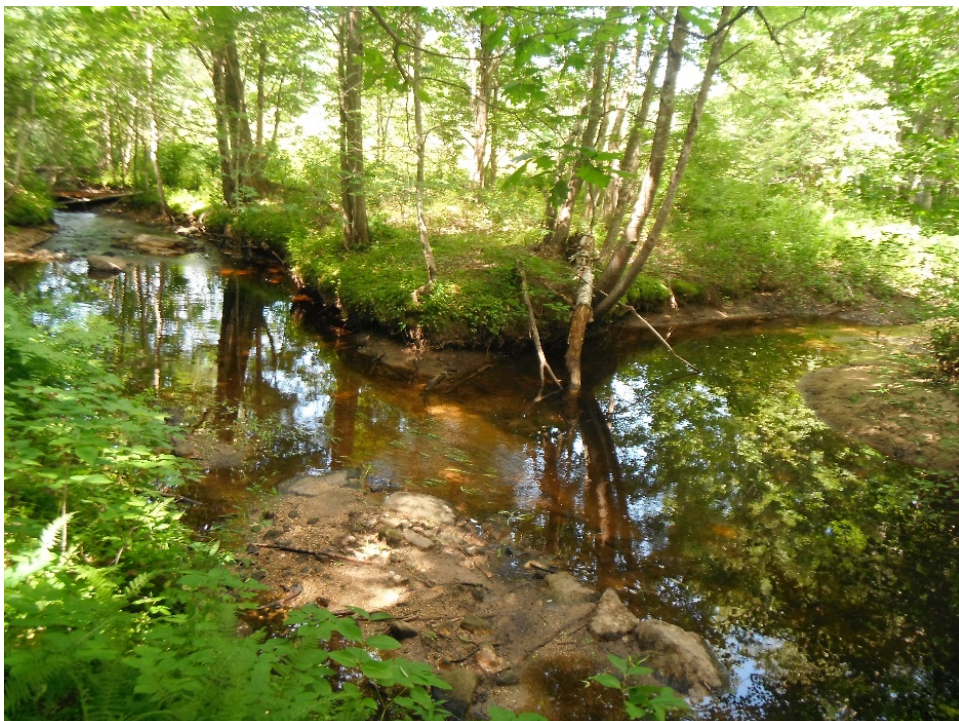
Photo 5. Junction of Cold Brook (right) and Adams Brook (left).

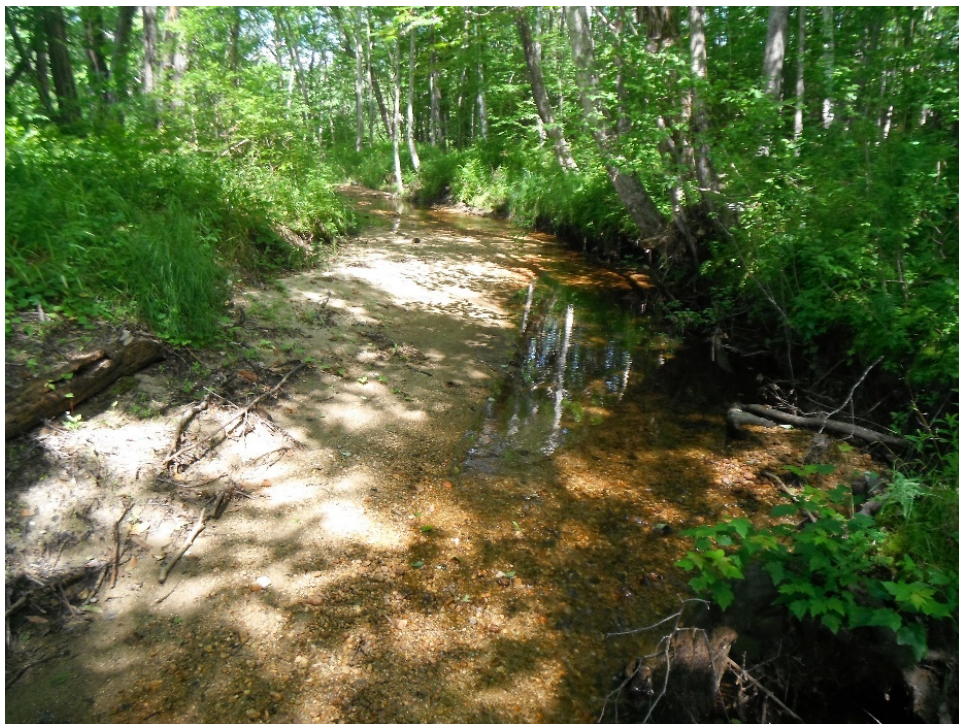
This segment was approximately 0.35 RM and extended from the confluence with Adams Brook to the culvert crossing under Adams Road (Figure 1). This section of Cold Brook had poor fish habitat with shallow pools with sedimentation and no or little large woody debris or habitat complexity (Photos 6 and 7). There were several active beaver dams observed which created slow and deep pools upstream. This section of Cold Brook appeared historically straightened, perhaps from historic development and construction of the old golf course adjacent to the brook. A berm was observed on the left stream bank constricting the floodplain downstream of Adams Road. There were blacknose dace (*Rhinichthys atratulus*) observed in this section; however, overall, it had low quality brook trout habitat. There was gravel present for brook trout spawning but minimal riffles or complex habitat and most of the section consisted of runs or pools.

Photo 6. Fine sediment dominating the stretch of Cold Brook from the confluence with Adams Brook upstream to the Adams Road crossing.

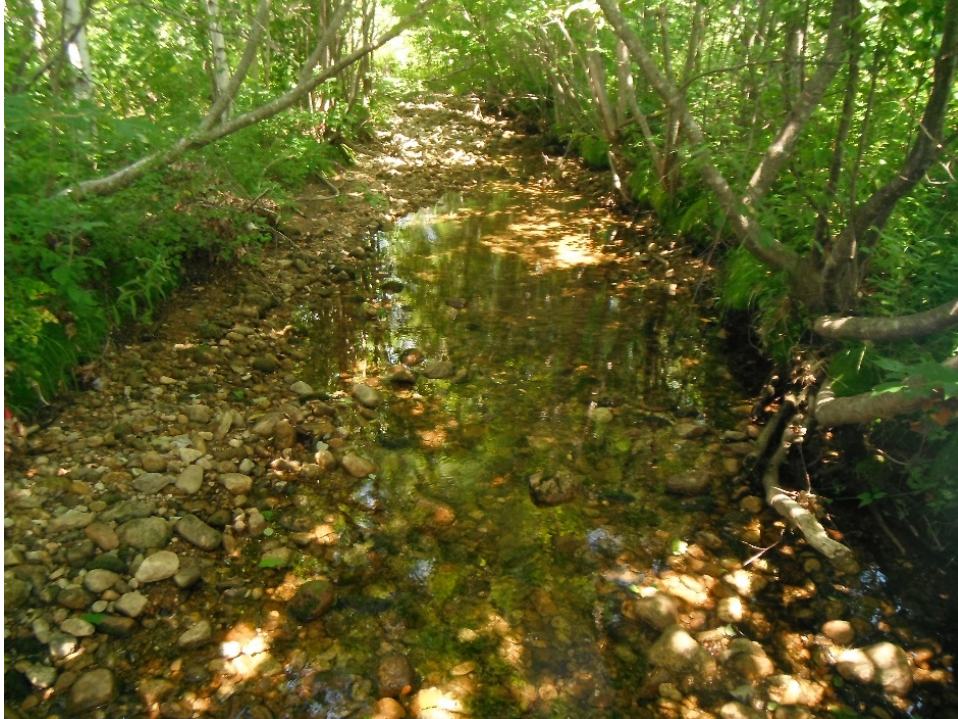
Photo 7. Planebed and channel stream habitat downstream from the Adams Road crossing.

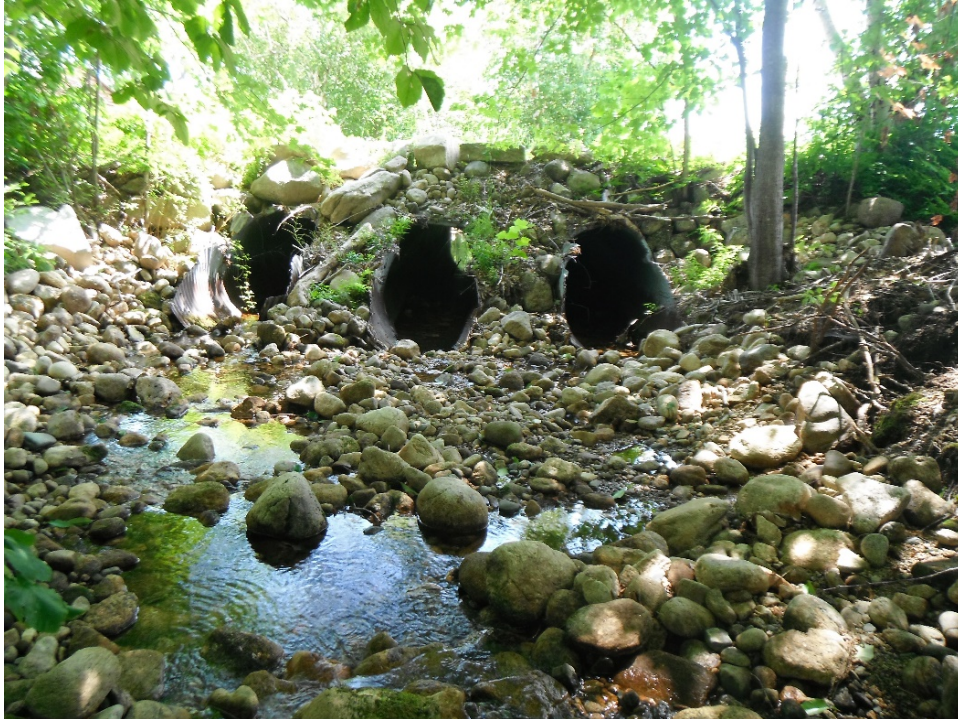
This segment of Cold Brook extended 0.7 river miles from the crossing with Adams Road up into the WMNF (Figure 1). The segment began with three culverts conveying the brook under Adams Road, which showed signs of being undersized and impeding natural fluvial geomorphic processes with scour and stream substrate deposition at the culvert inlets (Photo 8). The lower reaches of this segment had lower quality brook trout habitat with a plan-bed stream channel and very little habitat complexity or heterogeneity (Photo 9). Throughout Segment 4, there was vegetated riparian buffers and forested canopy. The stream banks were historically armored with larger rocks along the western bank in proximity to some residential development. Farther upstream in the WMNF, Cold Brook steepened and the fish habitat improved into a typical step/pool system dominated by boulders (Photo 10). The second brook trout (a single adult approximately 5–6 inches) was observed in the upper reaches of this segment in an area with some deeper bedrock pools.

Photo 8. Three barrel culverts under Adams Road.

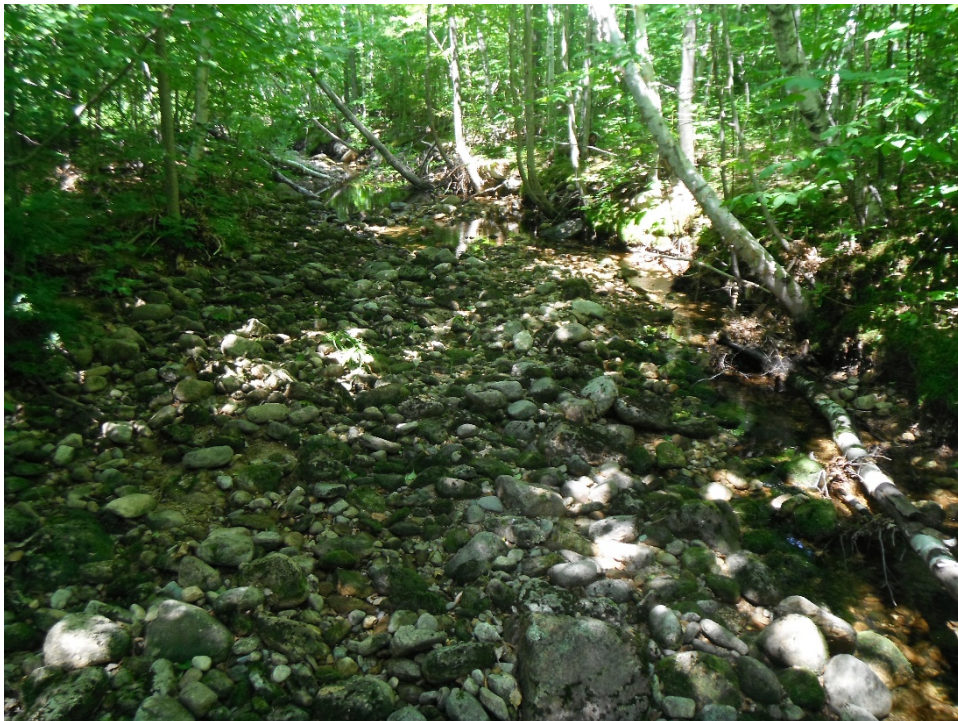
Photo 9. Lower section of Segment 4 with a planbed stream channel and very little habitat complexity.

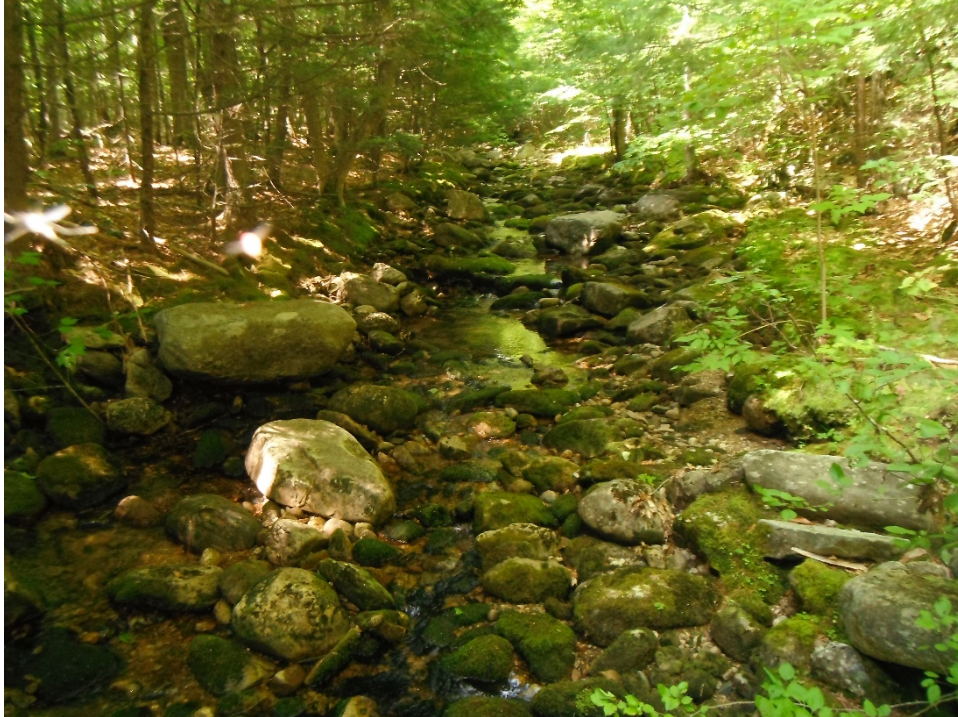
Photo 10. Better trout habitat in the WMNF with step-pool boulder steeper system and no human disturbances.
