To:	Ray Senecal Kezar Lake Watershed Association	From:	Nathan Henderson Topsham, Maine
File:	Stantec PN 195600843	Date:	November 27, 2012

Reference: Summary of 2-day Salmonid Spawner and Habitat Survey in the Great Brook Watershed

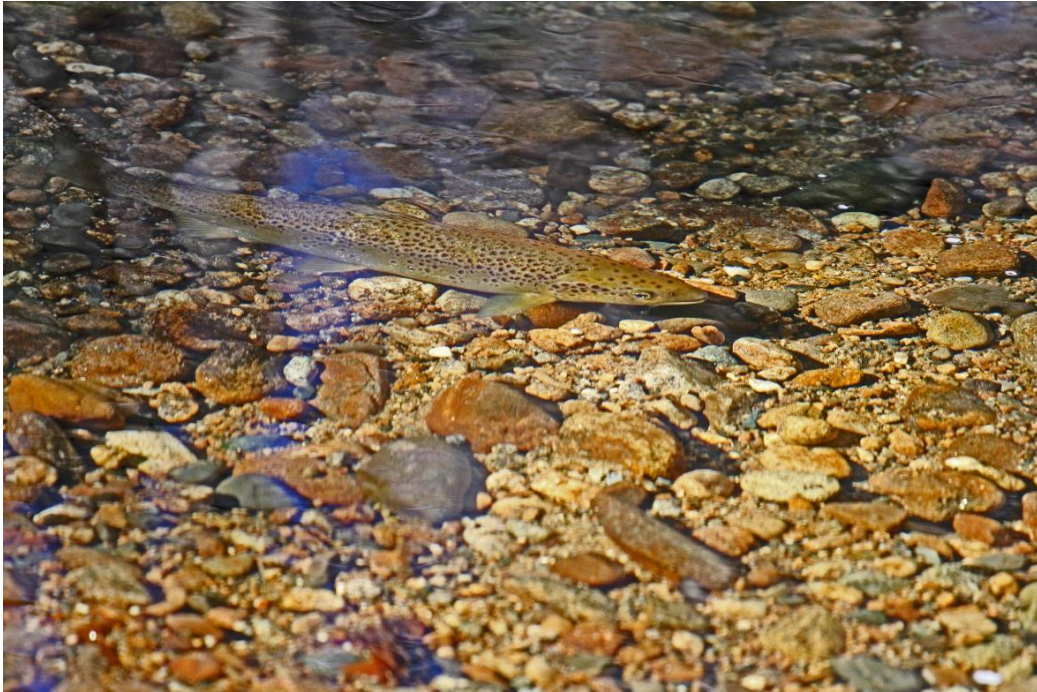
is dominated by small to large size gravel that is ideal for spawning (Photo 1). Just below the Beaver Brook confluence, a bedrock ledge cascade structure has historically been considered an impediment to yearly fall landlocked salmon spawning migrations (Photo 2). Upstream of Beaver Brook, Great Brook narrows and steepens with bedrock and boulder plunge pools. Upstream of this section to the Dwyer's Falls (Photo 3), Great Brook has high quality salmonid spawning habitat with deep pools and successive riffle-pool-run habitat complexes with gravel dominated pool tails. Upstream of Dwyer's Falls, Great Brook narrows and deepens with fewer riffles downstream of a steep bed-rock cascade section leading up to the bridge crossing at the end of Hut Road. From the Hut Road Bridge to the Red Rock Brook confluence, Great Brook's gradient relaxes back to approximately 2 or 3 percent with an accessible bankfull floodplain. The "chop and drop" habitat restoration efforts have resulted in high quality habitat with woody debris piles providing habitat cover and complexity. The substrate in the upper Great Brook watershed is larger than the section below Beaver Brook, with a higher percentage of cobble and boulders, but adequately sized gravel for spawning were present in select pool tails. Upstream of Red Rock Brook, there is a 1,000-foot section of impassable steep cascading bedrock. Before the confluence with Shirley Brook, Great Brook flattens out again with adequate salmonid spawning habitat.

Photo 1. Landlocked salmon on spawning redd in Great Brook.

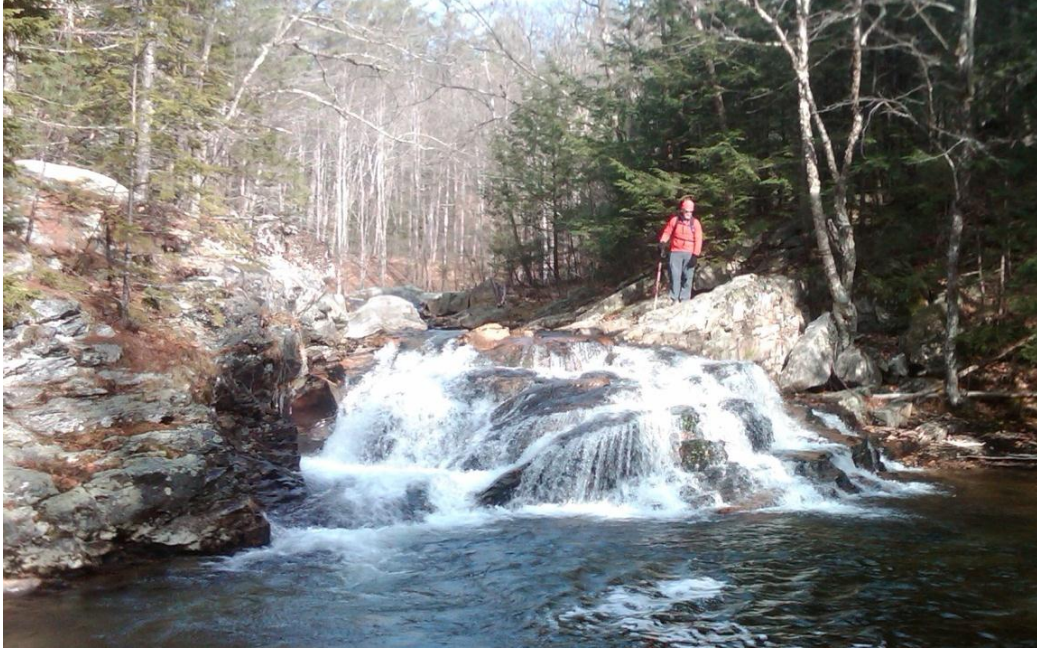
Photo 3. Dwyer's Falls in Great Brook.

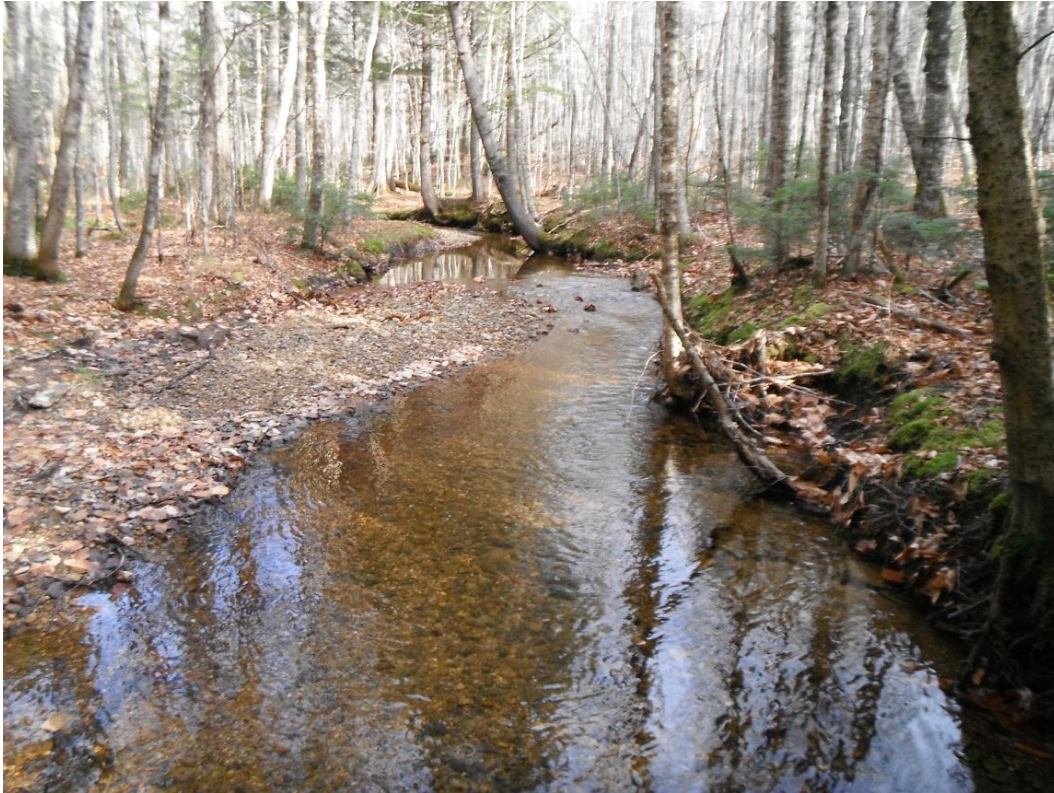
Approximately 2.28 RM were surveyed in Beaver Brook upstream from its confluence with Great Brook (See attached map). The survey concluded where Beaver Brook drastically steepened and the plunge pool habitat became dominated with boulder/cobbles. Upstream of the confluence with Great Brook to the double culvert Beaver Brook Road crossing, Beaver Brook is moderately steep (~4% gradient) with minimal sub-habitats of gravel suitable for spawning. Upstream of the road crossing, Beaver Brook flattens (~2% – 3% gradient) with successive riffle-pool-run habitat complexes with large woody debris providing cover and high quality brook trout habitat (Photo 4). The stable banks have floodplain access at bankfull flows and streamside riparian vegetation provides stabilization and canopy cover. The substrate above Beaver Brook Road has ideal gravel composition for brook trout spawning. No landlocked salmon redds were observed in Beaver Brook and only one marginal (small and indistinct) brook trout redd was documented in lower Beaver Brook. However, 13 1-inch to 3-inch and 4 4-inch to 7-inch brook trout were observed in Beaver Brook indicating successful spawning throughout the surveyed reach, especially upstream of Beaver Brook Road.

Photo 4. High quality brook trout habitat with gravel bar in Beaver Brook above the road crossing.

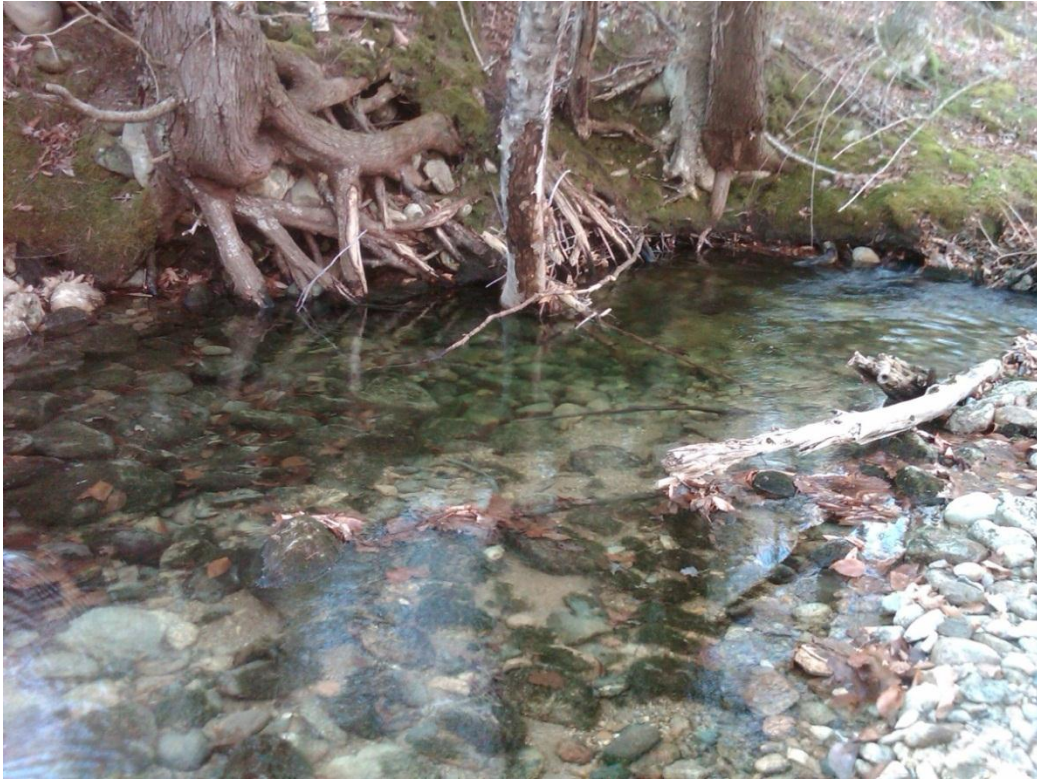
Approximately 0.92 RM were surveyed in Willard Brook from the confluence with Great Brook to the high gradient feature at the headwaters of the Brook (see attached map). The lower reaches of Willard Brook can be characterized as a moderately steep tributary (~2% – 3% gradient) with a high percentage of medium to large gravels, small cobble, and very suitable spawning substrate for both brook trout and landlocked salmon. The lower reach also contains very high quality pool habitat for brook trout (Photo 5); however, only 2 small brook trout were observed in the tails of pools. The upper reach of Willard Brook transitions to a higher gradient habitat (~3% – 6% gradient) that contains mostly riffle runs with interspersed pocket pools. The pools in the upper reach were dominated by undercut banks that were formed by overhanging vegetation at the stream margins. Very little spawning substrate was observed in the upper reaches as large cobbles, boulders, and bedrock dominated the substrate of this stretch. It is presumable that if the impediment formed at Dwyer Falls in Great Brook could be modified to pass both smelt and landlocked salmon, that the lower Willard Brook would offer very high quality spawning and rearing habitat. The introduction of smelt and landlocked salmon in Willard Brook would have to be assessed to determine possible negative impacts to the native brook trout that rely on this very high quality habitat.

Photo 5. Natural pool habitat in Willard Brook.

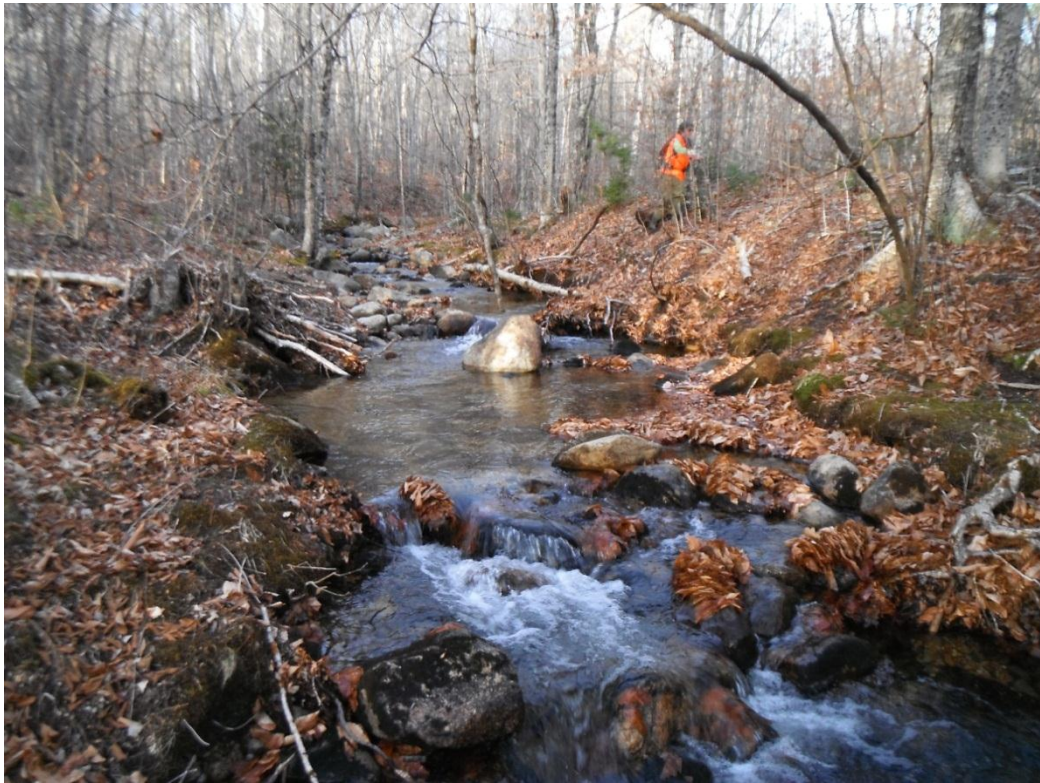
Approximately 0.42 RM were surveyed in Red Rock Brook from its confluence with Great Brook to Red Rock Falls (see attached map). Red Rock Brook is a steeper tributary (~4% – 6% gradient) with a higher percentage of cobble and boulders versus more suitable salmonid spawning substrate of small to medium gravel. However, there were pockets of small to medium size gravel inter-dispersed in pockets in pool tails suitable for spawning (Photo 6). No brook trout or landlocked salmon redds were observed in Red Rock Brook. However, a total of six 1-inch to 3-inch brook trout and six brook trout greater than 4 inches were observed in a relatively small section of the brook. Seven of the 12 fish were observed in one large pool at the base of the expansive Red Rock Falls. The largest brook trout (~7 inches) observed in the Great Brook watershed was observed in this pool. The presence of multiple young-of-year brook trout is indicative of successful spawning in the lower portion of Red Rock Brook. It is presumable that brook trout unable to navigate the approximate 1,000-foot section of very steep bed-rock cascade in Great Brook just upstream of Shirley Meadows migrate up Red Rock Brook to access more quality habitat in the upper watershed.

Photo 6. Successive plunge pool habitat in Red Rock Brook.
