To:	Kezar Lake Watershed Association	From:	Jake Riley Topsham ME Office
File:	Stantec PN 195600843	Date:	April 10, 2020

Reference: Summary of Cold Brook Habitat Reconnaissance Survey

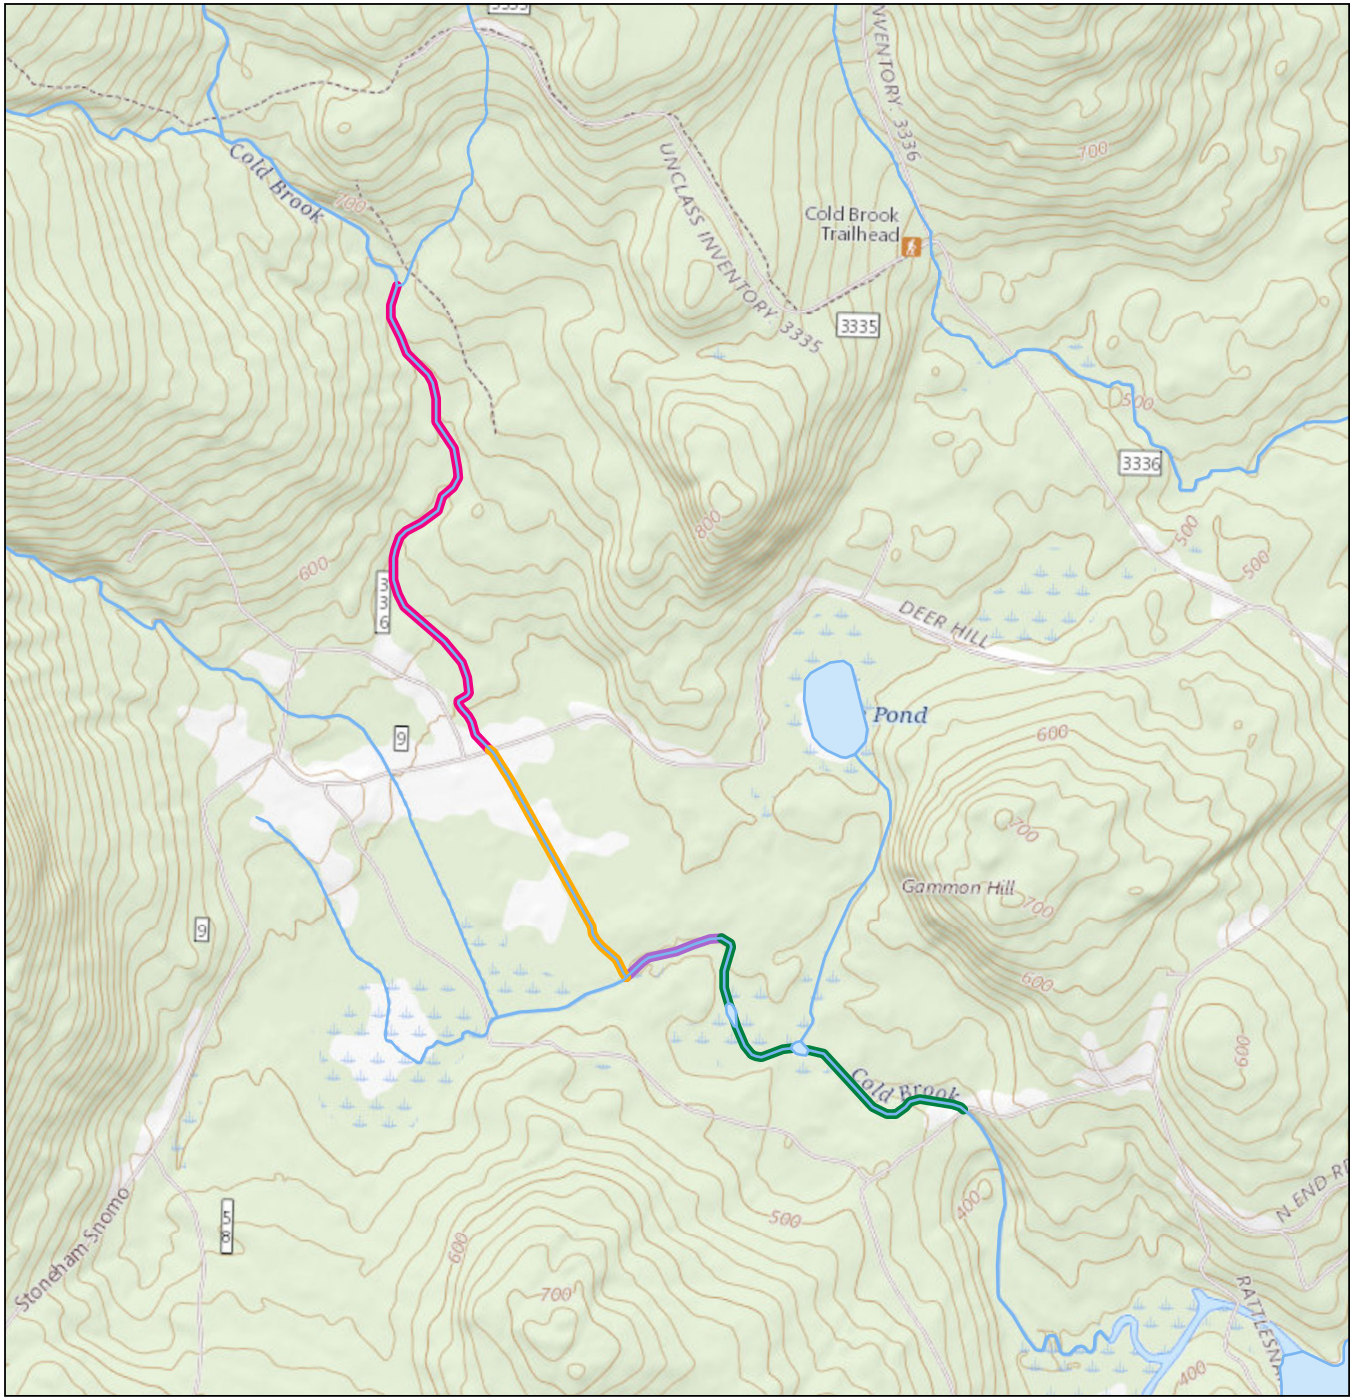
Attachment: Figure 1

Segment 1 was approximately 0.5 RM and extended from the Slide Brook bridge upstream to the right angle turn in Cold Brook to the west (Figure 1). This lower section of Cold Brook had good canopy cover and riparian vegetation consisting of mixed hardwood forest (Photo 1). The higher quality stream habitat in this lower segment included plunge pools with a stable boulder and bedrock dominated substrate with fine sediment settled out in the deeper pools (Photo 1). One brook trout young-of-year was observed in this steeper high-quality habitat, however, there was minimal evidence of appropriately sized gravel for brook trout spawning. Upstream of this lower section was a beaver-influenced long flatter reach dominated by deep pool and runs including a large pond feature that was too deep and dark to observe any fish (Photo 2). The pond habitat was at the confluence of the tributary draining Little Pond from the north (Figure 1). Above this reach, there was a long stretch of Cold Brook in an open meadow that was dominated by beaver activity with active lodges and multiple blown out beaver dams (Photo 3). The beaver dams held back some spawning substrate (i.e., gravel) but there was a lack of riffles and/or pool tails with well-oxygenated water preferred for spawning. Just before the right angle turn to the west at the upstream limit of Segment 1, there was a steeper reach with more canopy cover, cobble substrate, and two exposed blue PVC pipes in the stream channel, which could have been used for water irrigation for the historic golf course located adjacent and to the east of Cold Brook.

This short segment (approximately 0.15 RM) of Cold Brook was dominated by slow moving pools and runs with sedimentation and large woody debris jams (Figure 1, Photo 4). At the junction of Adams Brook and Cold Brook, there was approximately twice as much flow in Adams Brook than Cold Brook (Photo 5). Both tributaries were dominated by fine sediment in the stream bed. This section of Cold Brook did not have preferred brook trout habitat and no fish were observed in this section.

This segment was approximately 0.35 RM and extended from the confluence with Adams Brook to the culvert crossing under Adams Road (Figure 1). This section of Cold Brook had poor fish habitat with shallow pools with sedimentation and no or little large woody debris or habitat complexity (Photos 6 and 7). There were several active beaver dams observed which created slow and deep pools upstream. This section of Cold Brook appeared historically straightened, perhaps from historic development and construction of the old golf course adjacent to the brook. A berm was observed on the left stream bank constricting the floodplain downstream of Adams Road. There were blacknose dace (*Rhinichthys atratulus*) observed in this section; however, overall, it had low quality brook trout habitat. There was gravel present for brook trout spawning but minimal riffles or complex habitat and most of the section consisted of runs or pools.

This segment of Cold Brook extended 0.7 river miles from the crossing with Adams Road up into the WMNF (Figure 1). The segment began with three culverts conveying the brook under Adams Road, which showed signs of being undersized and impeding natural fluvial geomorphic processes with scour and stream substrate deposition at the culvert inlets (Photo 8). The lower reaches of this segment had lower quality brook trout habitat with a plan-bed stream channel and very little habitat complexity or heterogeneity (Photo 9). Throughout Segment 4, there was vegetated riparian buffers and forested canopy. The stream banks were historically armored with larger rocks along the western bank in proximity to some residential development. Farther upstream in the WMNF, Cold Brook steepened and the fish habitat improved into a typical step/pool system dominated by boulders (Photo 10). The second brook trout (a single adult approximately 5–6 inches) was observed in the upper reaches of this segment in an area with some deeper bedrock pools.
